CIVIL AERONAUTICS BOARD

ACCIDENT INVESTIGATION REPORT

PAN AMERICAN WORLD AIRWAYS, INC., - NEAR CAROLINA, BRAZIL,
APRIL 29, 1952

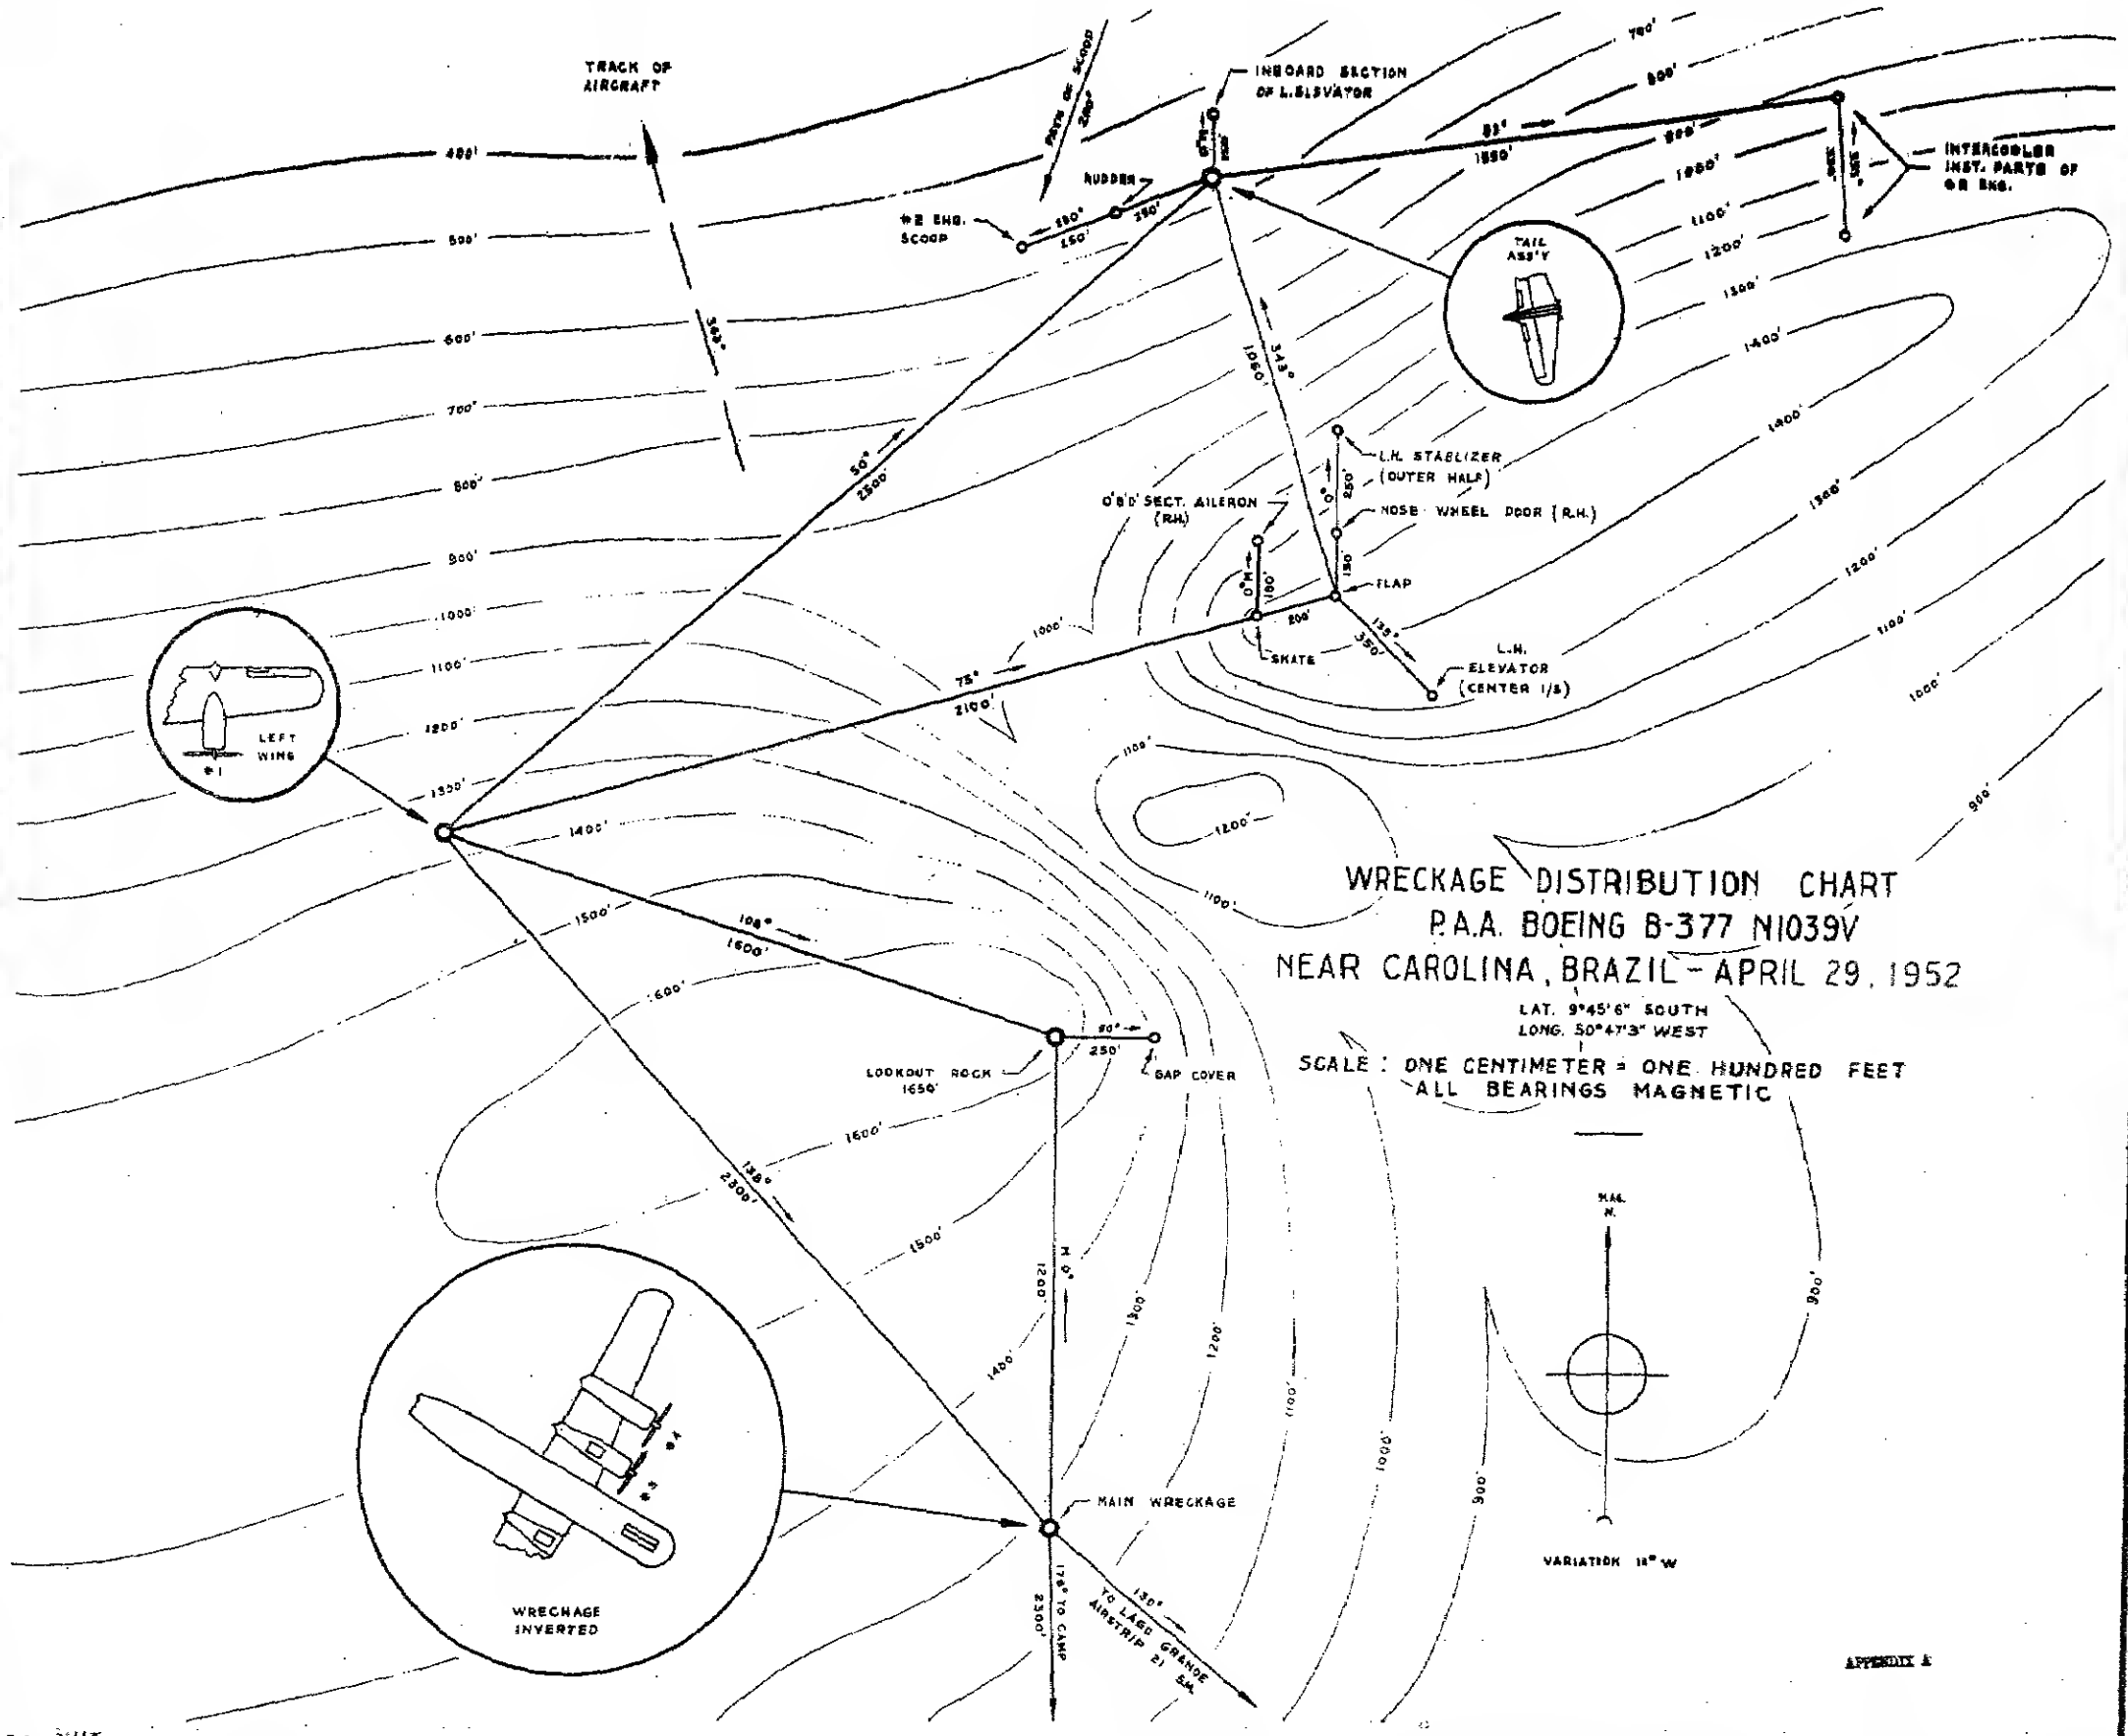
WRECKAGE DISTRIBUTION CHART
P.A.A. BOEING B-377 N1039V
NEAR CAROLINA, BRAZIL - APRIL 29, 1952

Most of the remaining structural parts of the aircraft were found within an area encompassed by a circle of approximately a 350-foot radius. From the center of this circle, the distance to the tail assembly wreckage was approximately 1,000 feet on a bearing of roughly 340 degrees. These parts included the outer portion of the left horizontal stabilizer, the middle portion of the left elevator, two inboard pieces of the left flap, the right-hand nose wheel well door, and the tip section of the right aileron. (See Chart, Appendix A.)

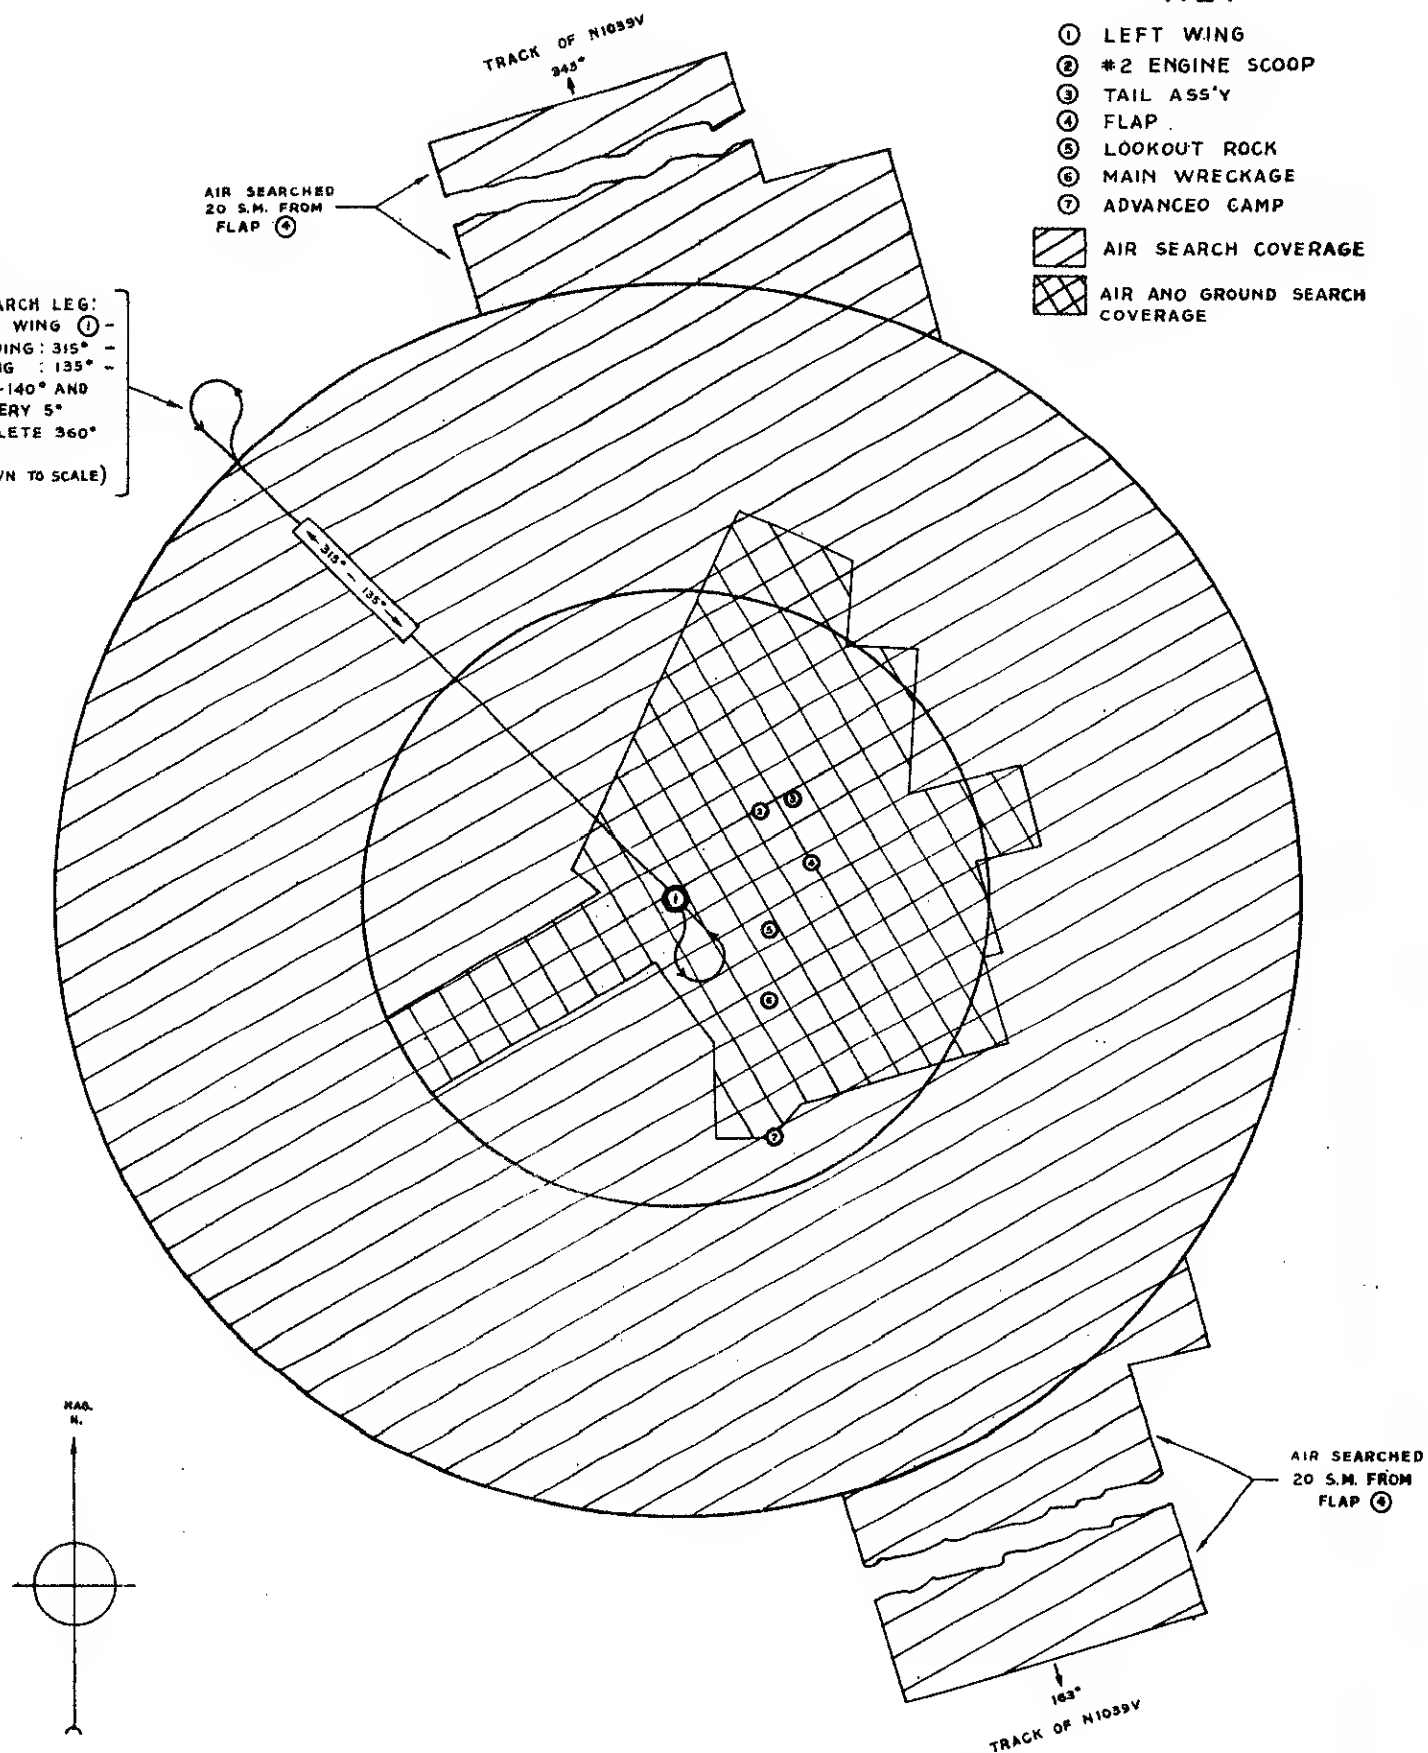
AIR-GROUND SEARCH FOR #2 ENGINE-N1039V

Extensive ground and air search^{3/} failed to locate the No 2 engine with its mounted accessories or No 2 propeller. Examination, therefore, was limited entirely to those portions of No 2 power plant which were recovered. With the exception of the left diagonal of the lower "V" strut assembly, the major portion of the engine mount structure from the ring mount aft to the point of attachment to the wing structure was recovered with the fuselage and right wing wreckage.

TYPICAL AIR SEARCH LEG:
OVERHEAD LEFT WING ① -
OUTBOUND HEADING: 315° -
INBOUND HEADING: 135° -
NEXT LEG: 320°-140° AND
INCREASING EVERY 5°
THROUGH COMPLETE 360°
COVERAGE.
(TURNS NOT DRAWN TO SCALE)
